Passaic Valley Sewerage Commissioners
Newark, New Jersey

**BROWN STREET BRANCH
INTERCEPTOR EVALUATION**

Clinton Bogert Associates

July, 1981

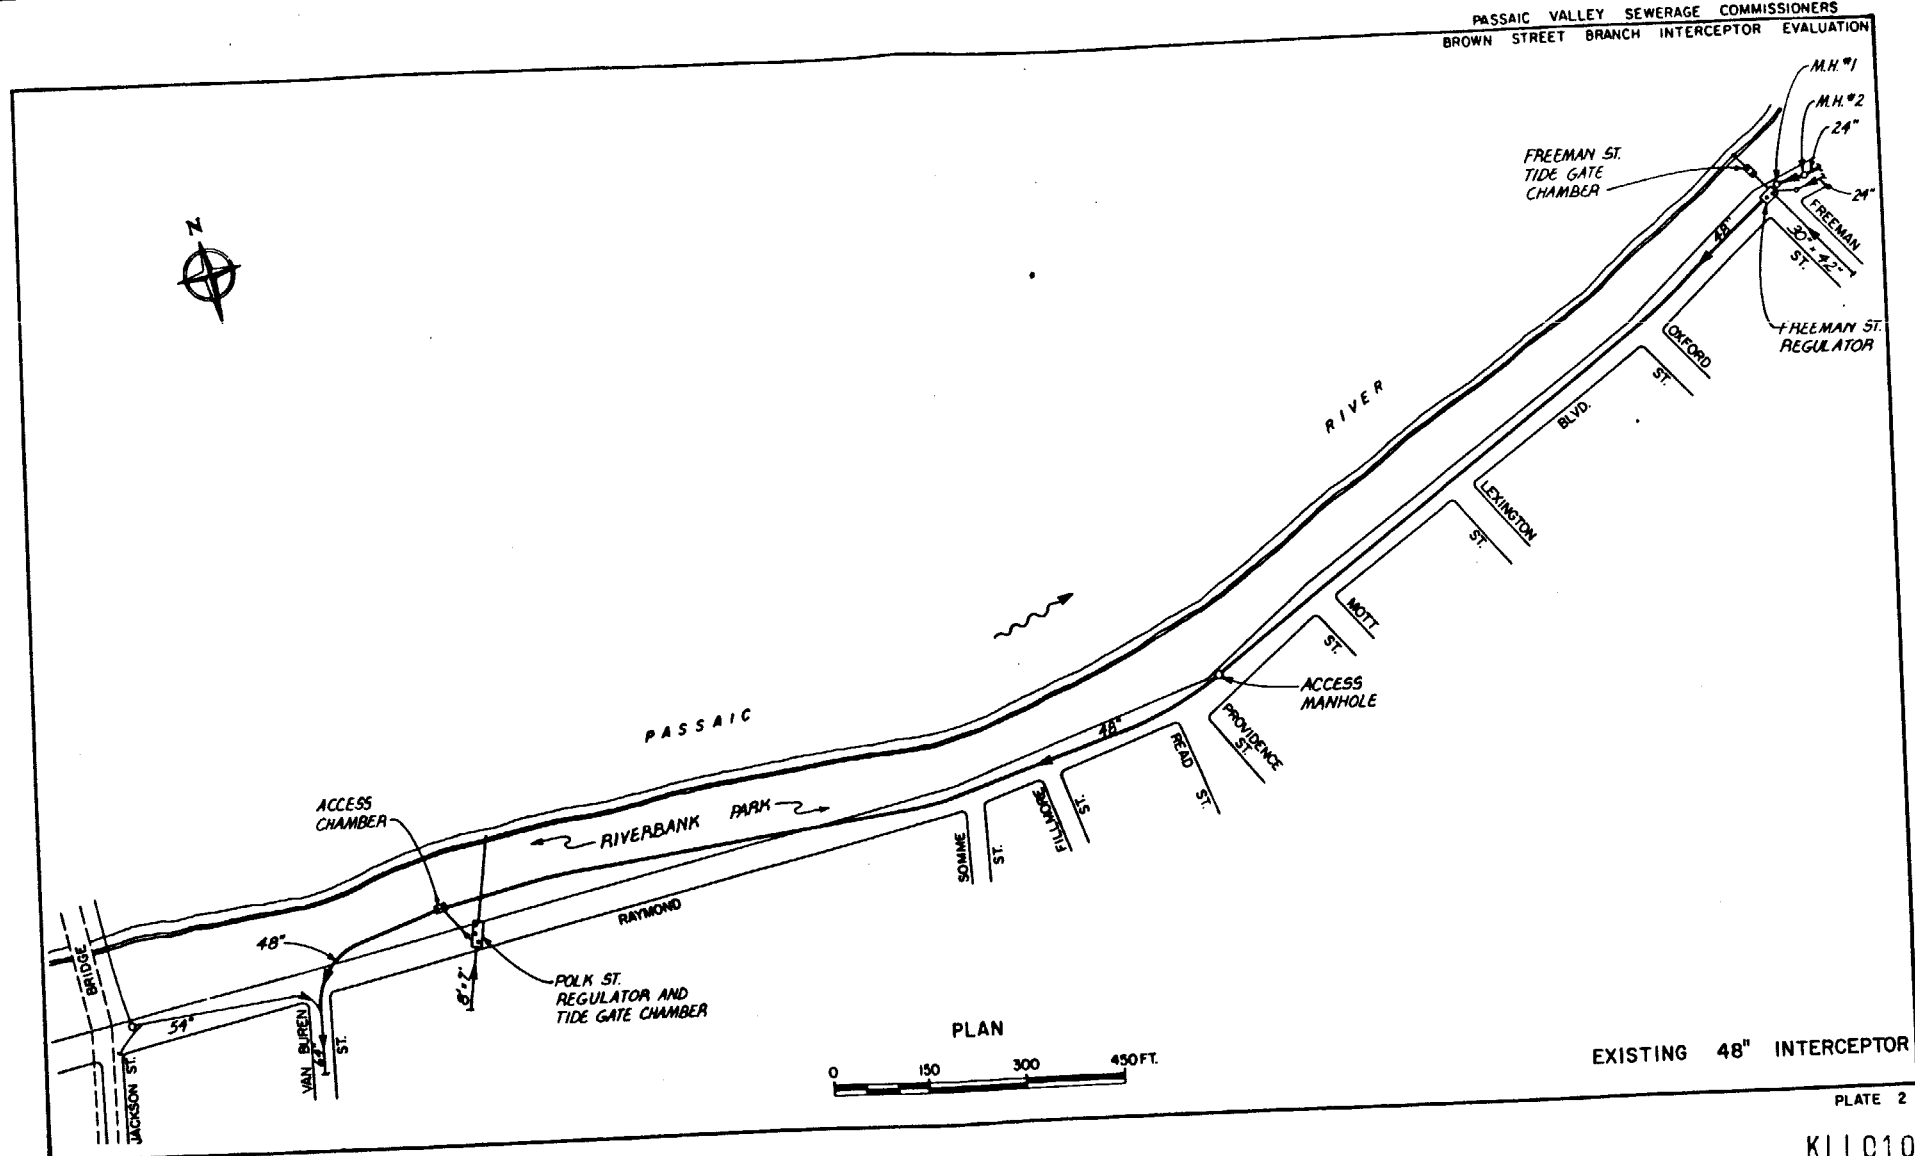
PLATE 2

It was found that the interceptor had deteriorated to an alarming degree between the Van Buren Street Interceptor and the access chamber at Polk Street. The 36-inch brick transition section at the

downstream end was missing 20 percent of its bricks. The wall of the sewer had been completely eroded at the normal flow line for the first 25 feet, and much of the invert was missing. Holes in the tunnel lining and deep grooves were reported at the flow line for much of the first 275 feet. The holes were between one and seven feet long and varied in height between six and twelve inches. Measurements showed that the cross-section was not circular. The vertical dimension appeared to be elongated and the horizontal dimension appeared to be compressed. These variations in the cross-section were not observed upstream of Polk Street possibly indicating that they may not be the result of poor control during construction. Some of the apparent vertical elongation may be the result of erosion of concrete in the sewer invert.

Erosion of the interceptor was not so severe between the access chamber at Polk Street and the regulator chamber at Freeman Street. Grooves were found in the walls at the flow line along the entire length of the tunnel. These grooves were, in many cases, only one or two inches deep. Occasional holes through the tunnel wall were reported. The map in Appendix "A" shows the location of the holes in the interceptor in relation to surface subsidence areas. It can be readily seen that most holes reported correspond closely to the location of surface settlements. The depths of sediment found downstream of the holes would indicate that significant amounts of soil have entered the tunnel through the holes.

4. It is recommended that the interceptor be rehabilitated by shotcreting as shown on Plate No. 10. Temporary pumping

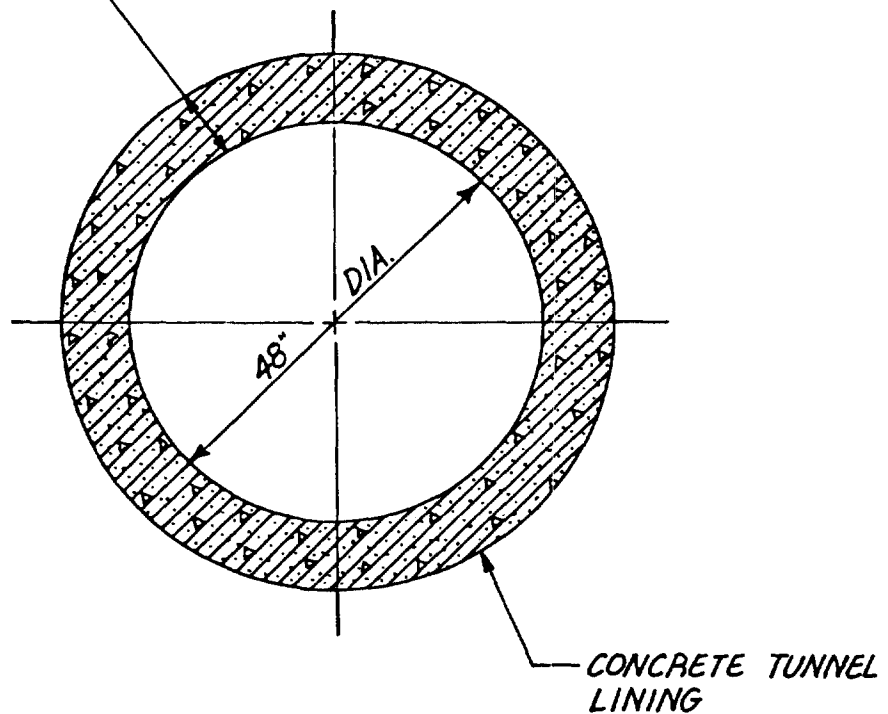
TYPICAL CROSS SECTION
48" INTERCEPTOR

Construction plans indicate that the tunnel was advanced using a timber exterior liner against which concrete was poured. Nominal concrete wall thickness varied between eight and eleven inches. The concrete was not reinforced. A typical cross-section of the tunnel is shown on Plate No. 6. The tunnel was designed so that soil and water pressures on the exterior of the circular tunnel would create forces directed at the tunnel's geometric center. These forces cause compressive stresses within the tunnel's concrete lining. Since no tensile stresses are created, no reinforcing steel is required theoretically. Secondary factors such as shrinkage, creep and temperature could reduce the compressive stresses somewhat. It does not appear that the present condition of this interceptor is the result of faulty design.

The diver's report clearly indicates that the walls of this sewer have been severely eroded from the inside. Chemical damage in this interceptor was first detected during the 1930's. The industries responsible were fined for dumping acidic wastes. There have always been major chemical industries tributary to the Brown Street Branch Interceptor and the line may have been subject to chemical attack throughout its service life. It is significant, however, that the damage to the interceptor is confined to the area below the spring line. The crown of the tunnel remains intact except at the brick transition into the Van Buren Street Interceptor.

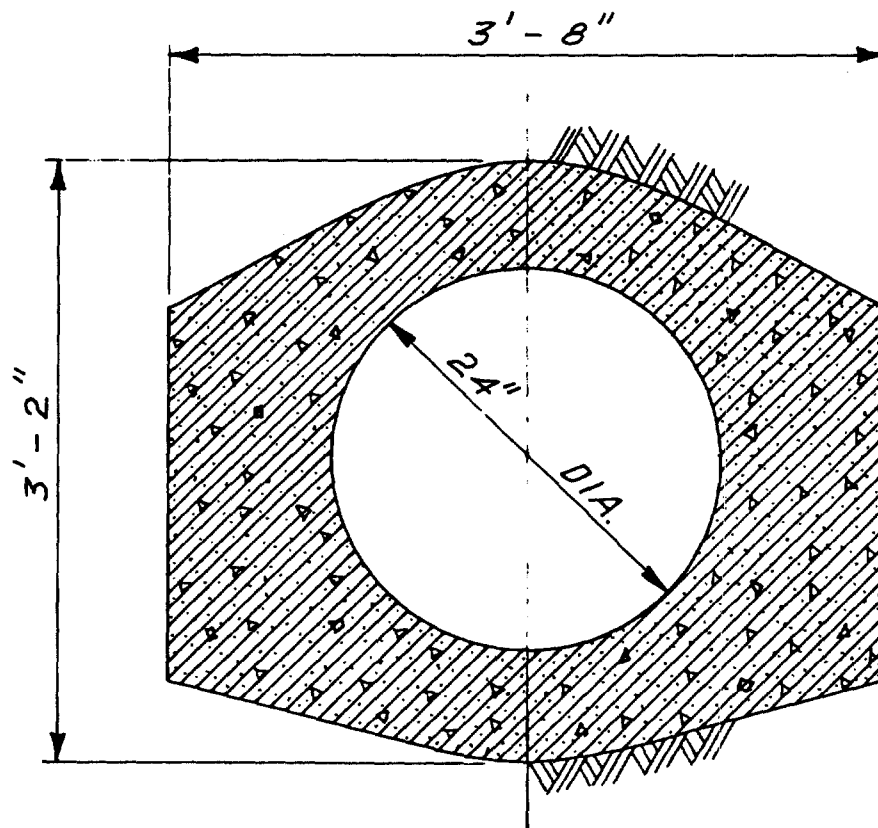
TYPICAL CROSS SECTION
24" INTERCEPTOR

The condition of the 24-inch interceptor is only partially known. The extent of concrete erosion below the flow line has not been determined. Based on the condition of the 48-inch interceptor downstream, extensive damage is probable. The possible settlement of

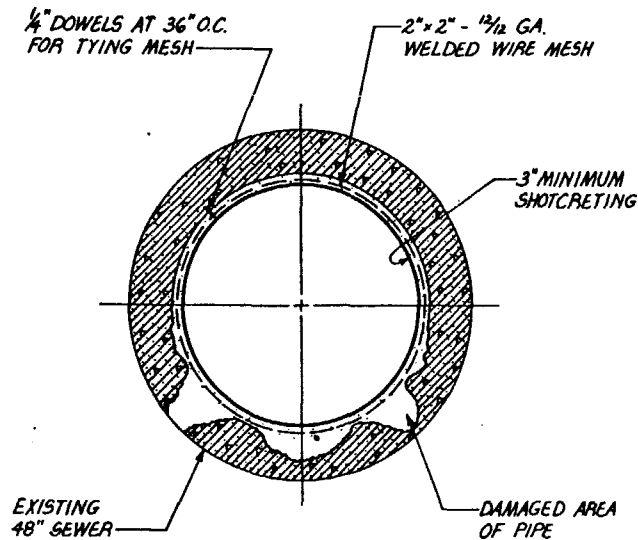
FULL SECTION

VAN BUREN STREET INTERCEPTOR TO
POLK STREET ACCESS CHAMBER

The lining of the existing tunnel could be restored and reinforced using shotcrete. In this method, the interceptor would be taken out of service by installing temporary bypass pumping facilities at Polk and Freeman Streets. Three additional access chambers would be constructed to facilitate rehabilitation operations and future maintenance of the line. The locations of the proposed access chambers and bypass pumping facilities are shown on Plate No. 9. After the interceptor was taken out of service, sediment would be removed and the interior would be washed and sandblasted. All loose or deteriorated concrete would be removed. Holes in the lining would be grouted and additional grout would be injected into voids in the soil outside the tunnel. Steel mesh would then be attached to the interior of the interceptor and sprayed with concrete. The existing tunnel lining would be restored and an additional three inches of concrete would be added. This additional concrete would not reduce the tunnel's diameter to less than 42 inches. In the structurally unsound portion of the interceptor between Van Buren and Polk Streets, steel mesh and concrete would be placed around the entire inner circumference of the tunnel. Upstream of Polk Street, concrete and mesh would be placed only below the spring line. The proposed restored cross-sections are shown on Plate No. 10. Test pits would be dug at the surface in known areas of subsidence or above holes found in the tunnel lining. Utilities would be located and borings obtained. Grout, select fill and bracing would be placed as required to prevent further settlement of the roadway and the utilities therein.

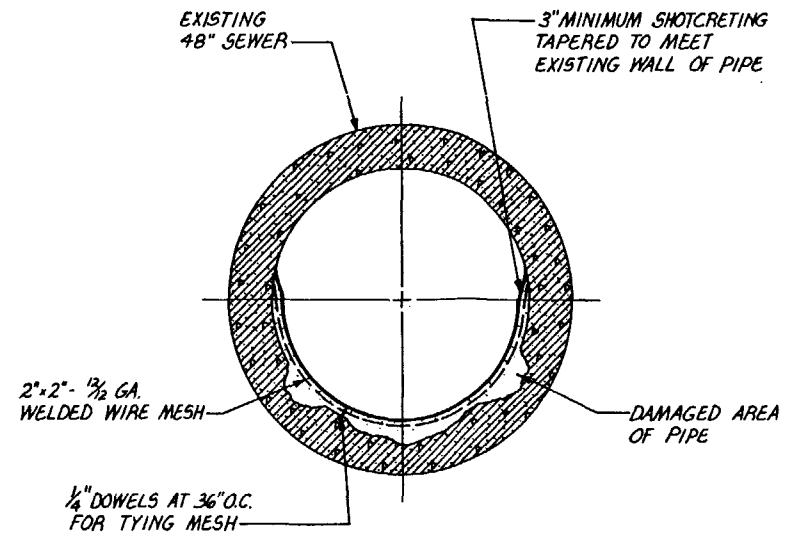
HALF SECTION

POLK STREET ACCESS CHAMBER TO
FREEMAN STREET REGULATOR
